THE ADOBE BARREL VAULTED STRUCTURES IN ANCIENT EGYPT: A STUDY OF TWO CASE STUDIES FOR CONSERVATION PURPOSES

Abdou A.O.D. El-Derby¹ and Ahmed Elyamani²

ABSTRACT

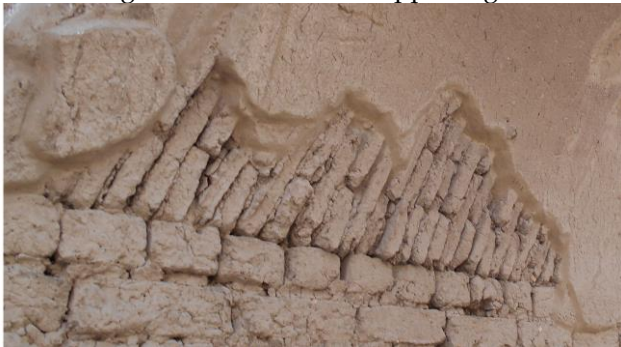
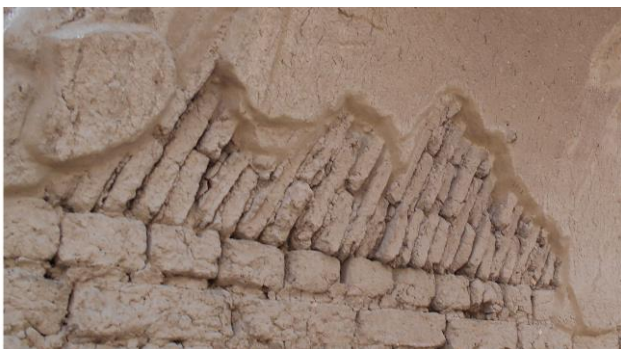
Figure 2. Mud-bricks laid tilted in an ancient Egyptian barrel vault (in the storerooms of the Ramesseum temple).

The adobe masonry barrel vaults in Ancient Egypt were constructed of courses of horizontal or upright mud-bricks laid tilted, at a slight angle to the vertical, against the supporting wall,

Figure 2 (Van Beck, 1987; Spencer, 1979). The inclination of the bricks from the vertical led most of the weight of each brick to transfer to the lower course which already had been laid rather than acting downwards, thus, the weight of each new brick was borne by those already laid. The brick was held in its position and stuck to the brick of the lower course by mud mortar.

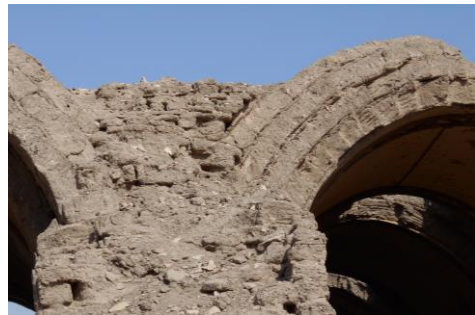
Figure 3. The adobe vault of the storeroom of the Ramesseum temple composed by four courses, the filling between the adjacent vaults can also be noticed.

The number of courses used to form the adobe vault was from one to four, as shown in Figure 1 (one course); Figure 6 (two courses) and Figure 3 (four courses). The spaces between the adjacent vaults were filled, sometimes, with rubble; as well filling was added above the vaults to create a flat surface, Figure 3.

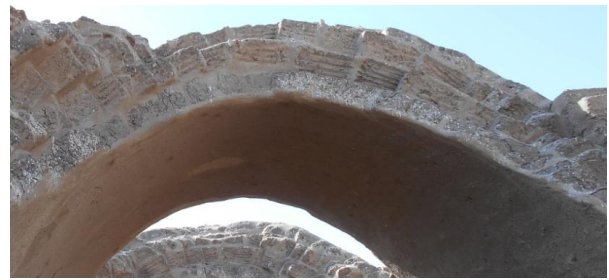
Figure 5. Bricks made with grooves to ensure the brick-mortar bond. The storerooms of the Ramesseum temple.

To ensure the brick-mortar bond, the brick was made with grooves arranged in parallel lines, Figure 5. The grooves were made by the workmen fingers during manufacturing process. The use of such bricks started as early as the Old kingdom period. These bricks were thin and were used in curved vaults. Also in the Old Kingdom period, sometimes special bricks were shaped with tooth-like snags.

cm. The vaults were constructed as a barrel vaults- as mentioned before-using adobe bricks of size 35 cm × 21 cm × 6~7 cm made with grooves (see again Figure 5), with filling spaces between bricks with fillers (such as fragments of stone and pottery). Any vault is composed by four courses of adobe masonry (see again Figure 3) resulting in a total thickness of about 80 cm, the vaults and walls were plastered with mud with a thick 3 and up to 10 cm. and

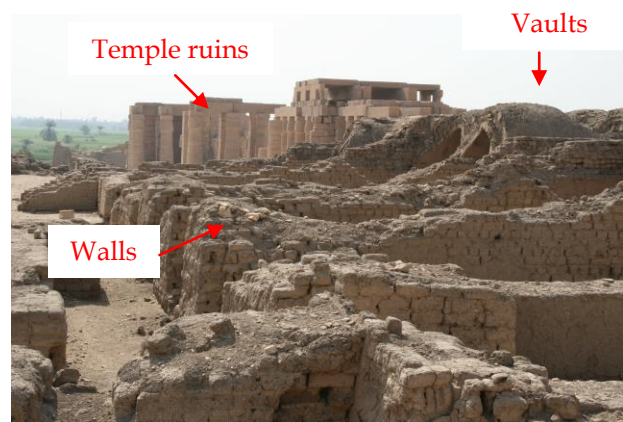
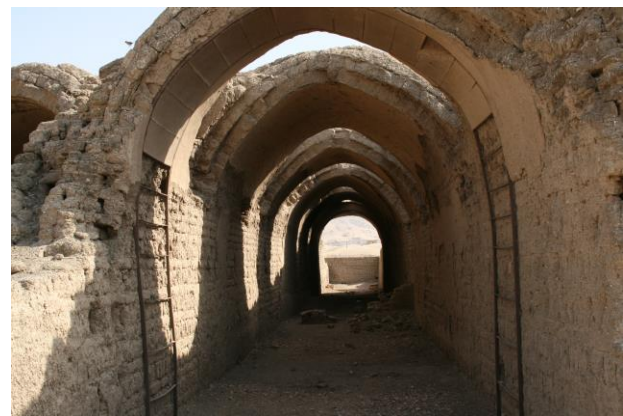
Figure 10. (a) The ruins of the Ramesseum temple and its storerooms vault and walls, (b) inside the storerooms.

storerooms, as can be noticed in the figure, can be divided into three groups. The focus of the current study is the group exactly behind the temple which is surrounded by red dashed rectangle, in view of its similarity with the second case study, in design and function, and in order that it is the oldest, the most interesting, compared to the other two groups. Photographical documentation of some of the remained parts is indicated in Figure 10.

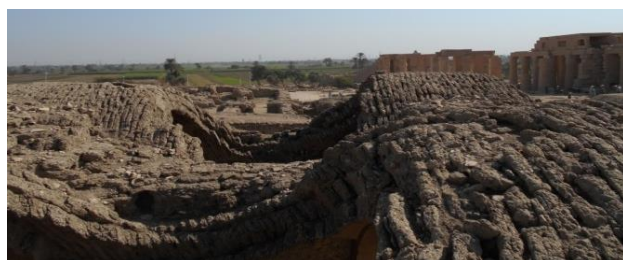
Figure 11. Current state of holes used in filling the storerooms with grains.

These storerooms were filled with grains from top via holes in the vault located each six meters, Figure 11. The holes were likely strengthened with stone frames and had covers. With time passing and due to different decaying factors, these holes became larger and representing nowadays weakness points participating in more collapses of vaults.

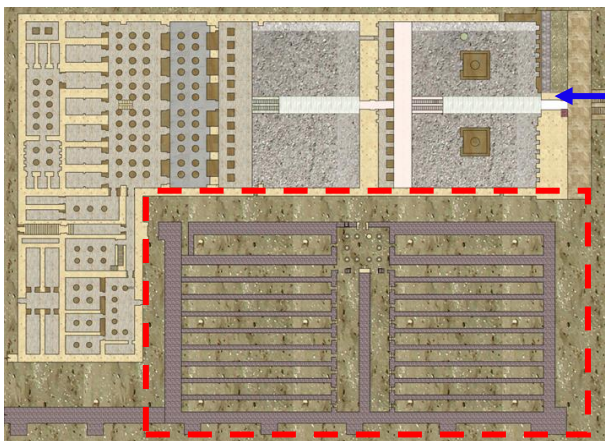
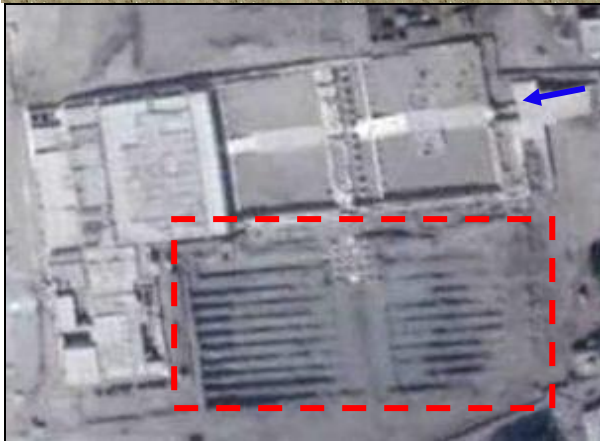
Figure 12. (a) 3D imagination of Sety I temple and its storerooms, and (b) The storerooms of Sety I temple are surrounded by red rectangle: plan view (top) and aerial view showing the current state (bottom). The blue arrow indicates the temple entrance.

The second case study is the storerooms of Sety I temple shown in Figure 12. Nowadays, only the walls exist and all the vaults were lost as can be noticed from the aerial view. They are located to the left from the temple entrance occupying an area around 103 m × 60 m. The number of storerooms tunnels is twenty, ten tunnels at each side. Each tunnel is about 38 m long and 2.2 m high. All the tunnels are about 3.5 m except two tunnels (see Figure 12) that are wider and have about 6 m width.

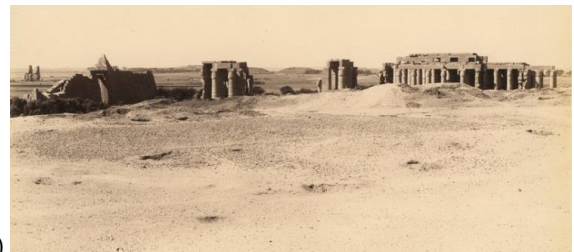
Figure 13. Photos date back to the last century before discovery of the storerooms: (a) The Ramessesum temple surrounded by filling from everywhere covering its storerooms, and (b) the storerooms of Sety I temple (in dashed red rectangle) covered by filling and houses.

Both storerooms were covered for long periods of time by large amounts of filling including rubble, debris and sand. This overloading is considered the main cause of collapsing of the vaults and the supporting walls. Photos date back to the last century showed clearly the filling above the storerooms before discovery, Figure 13.

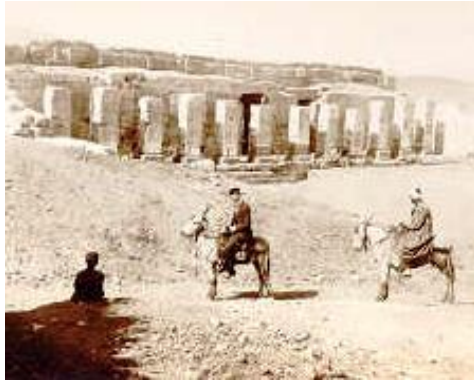
Figure 14. Photos date back to the last century before discovery of the storerooms of Sety I temple showing the villagers crossing over the covered storerooms with their animals.

The case of the storerooms of Sety I temple suffered from more damage causes than the storerooms of the Ramessesum temple. The villagers used to move over the covered storerooms with their animals, Figure 14. Furthermore, they destroyed a considerable part of the storerooms to build their houses in the same place, Figure 13. The early Copts escaped from persecution of the Roman emperors (before the recognition of the Christianity as the official religion of the Roman Empire) to these storerooms. They lived and worshiped in these storerooms and many other Ancient Egyptian temples. They looked to these structures as symbols of paganism; hence they destroyed and modified parts of these structures which participated in their damage (Ghazouli, 1964). A fire occurred and burnt these storerooms, a massive amount of animals burnt bones were found

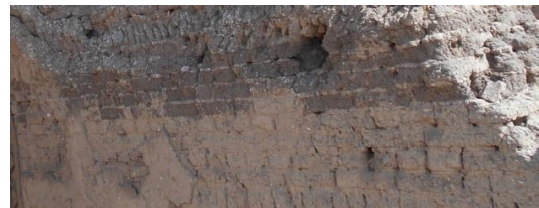
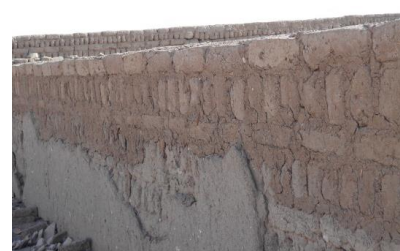
Figure 15. Many symptoms of damage in the storerooms of Sety I and the Ramesseum temples (a) cracking, (b) partial collapses, (c) holes widening, (d) erosion, (e) plaster detachment and (f) restoration using incompatible materials.

In addition to the large loosed parts from the storerooms, currently they are suffering from many damage symptoms as shown in Figure 15:

- Wide visible cracks in walls, vaults and plaster,
- Partial collapses and losses of bricks and mortar in vaults and walls,
- Widening of the top holes used in the past to fill the storeroom with grains,
- Erosion of walls and plaster,
- Detachment and losing of considerable areas of plaster,
- Inappropriate interventions using incompatible materials like red bricks and cement mortar.

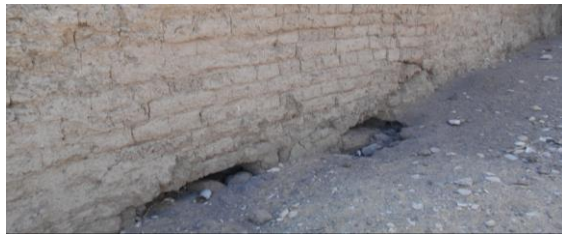
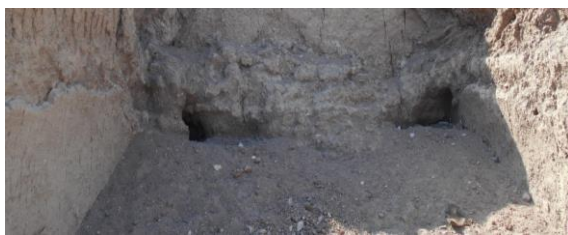
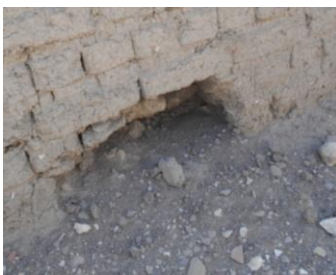
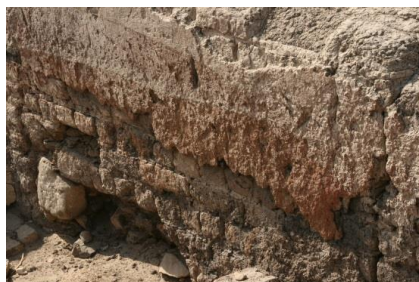
Figure 16. Holes made by animals (a) Sety I storerooms and (b) the Ramesseum storerooms.

Some animals like foxes and dogs made holes in the adobe walls of the storerooms to live in; Figure 16. These holes represent places of weakness due to decreasing the wall section at the base where the highest compressive stresses due to self-weight exist.

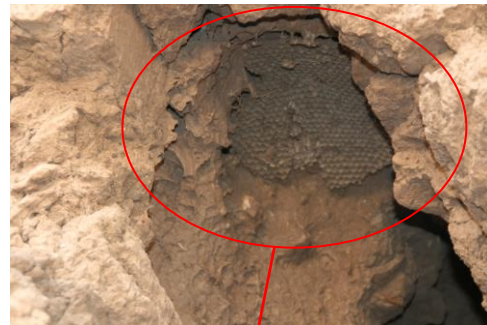
Figure 18. Wild bees nests found in the walls of the storerooms of the Ramesseum temple.

Ants and micro organisms attacked the storerooms structure to feed on the abundant chopped straw or chaff contained in the mud bricks. This resulted in reducing significantly the tensile strength of the adobe and consequently cracking and possible partial collapses occur in the attacked places. If no collapse occurs, such attack leaves the mud brick full of holes giving a bad appearance, Figure 17. In the Ramesseum storerooms, the wild bees participated in the deterioration of the adobe and evidences were found for their existence, Figure 18.

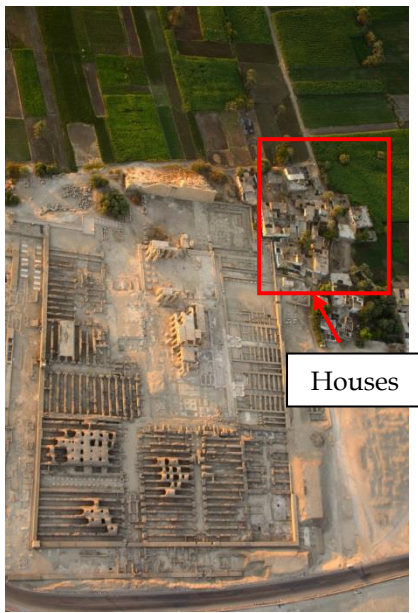
In the case of the Ramesseum storerooms, recently, the water table has risen due to the surrounding agriculture lands and houses, Figure 19. The ground water seeps into the bottom of the walls that absorbs the water by the capillary rise. This causes the swelling of the clay minerals contained in the adobe. Afterwards, the evaporation of water results in shrinkage and cracking, and after water drying the salts in the water crystallizes on the wall surface making it much more fragile, Figure 19. The wind blows re-

moves that fragile parts resulting in more erosion of the wall in a continuous process.

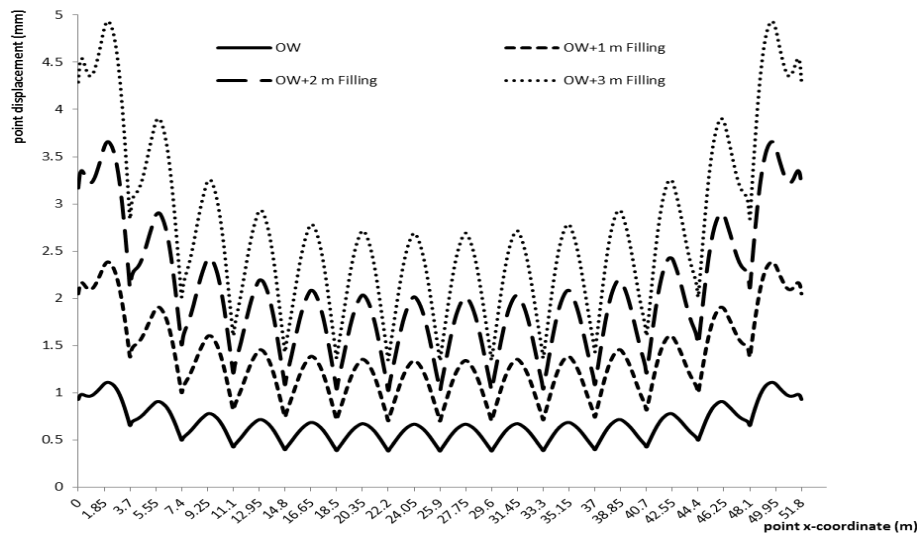
Figure 27. The effect of increasing filling depth on the Resultant deformations (m) of a selected transversal section “S-S” in the magazines of Ramesseum temple. OW=self-weight.

in the filling depth on the deformations, thus the strains and the stresses which resulted at end in the collapse of the vaults.

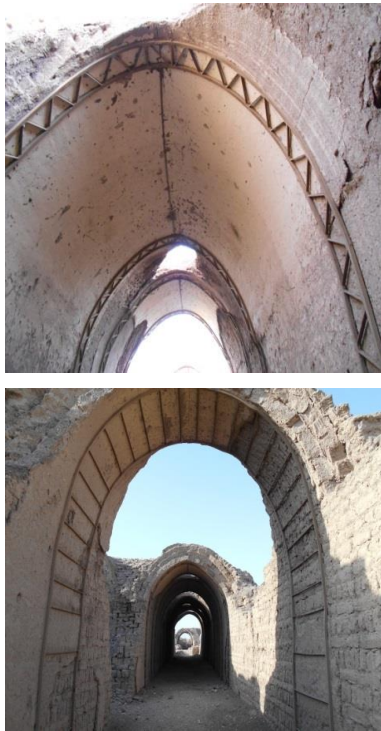
Figure 29. Two forms of the steel supporting structures used as strengthening interventions in the Ramessesum storerooms.

The existing parts of the storerooms of the Ramesseum were provided in earlier times with steel supporting structures, Figure 29. This strengthening intervention is believed to be one of the reasons behind the survival of these parts up to date. Therefore, it is proposed to apply the same intervention for the remaining parts of the Ramesseum storerooms. This intervention, however, has some disadvantages that should be avoided. First, it decreases the authenticity of the storerooms. Second, steel corrodes. Third, the compatibility in the mechanical properties between the steel and the adobe is low. The steel has much higher tensile and compressive strengths than the adobe. Finally, the steel is supporting the adobe structure and is not working with it monolithically. When the structure is subjected to the external forces, the steel structure does not absorb all the developed tensile strains and the adobe structure is subjected to some of them. Therefore, some cracks are present at the locations where the intervention exists as can be noticed in Figure 30.

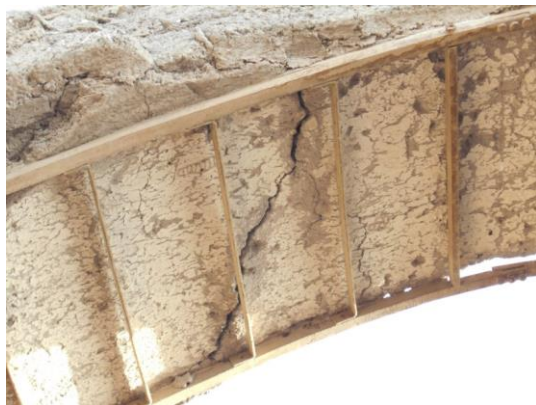
Figure 30. Large cracks at places of strengthening intervention.

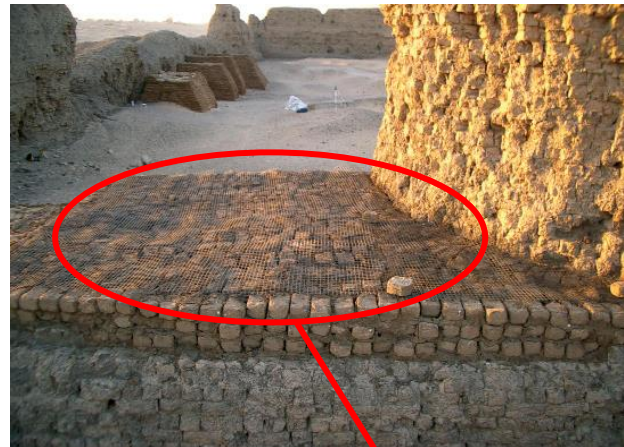
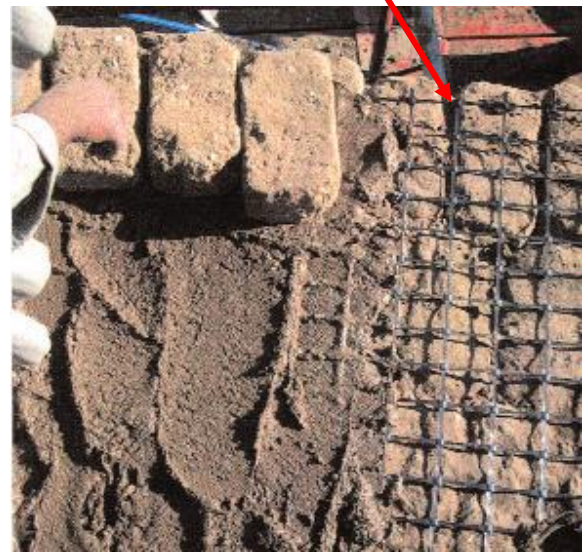
Figure 32. The application of polymer grids between adobe wall courses in Shunt el-Zebib in Abydos.
